MARINE SURVEY REPORT

Report Number : 2006P/1004

Date of Inspection : August 18, 2006

Make of Vessel -- Marine Trader built by Chien Wha Yard, Taiwan.
Name of Vessel -- Christiana
Model year -- 1985
Date of mfg. -- February 1985
License Number -- 25E 11189
HIN/MIC -- ETY345858585

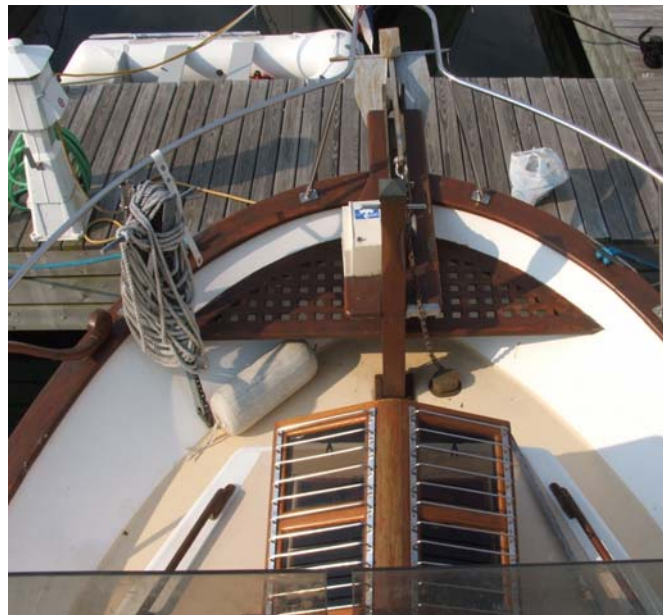
Stainless steel bow and side rails with teak caps are secure as are bow, midship and stern mooring cleats. A teak bow platform is fitted with a single anchor roller and is followed by a windlass and rode pipe. On the fore trunk a wooden hatch, two bronze ports and teak grab rails are secure and in good condition. The deck house checks sound with moisture levels in the low range. Two deadlights and an opening windshield forward are secure, on the house sides are a sliding companionway door, sliding windows and deadlights all of which are secure. On the trunk are two sliding windows and one deadlight all of which are secure. All sliding windows and deadlights have been sealed with a silicone type caulking material and leakage is suspected. All ports and windows are secure but most show signs of leaking. See comment (4).

4. Re-bedding all deadlights, ports and windows may help reduce leakage and further water staining.
7. Canada Shipping Act – TP1332E 7.7.1 requires every fuel filter or strainer shall meet the fire resistance requirements for fuel systems set forth in ABYC Standards for Small Craft H-24.5.7 unless the filter or strainer is inside the fuel tank. No plastic bowl filters without heat shields meet this standard.

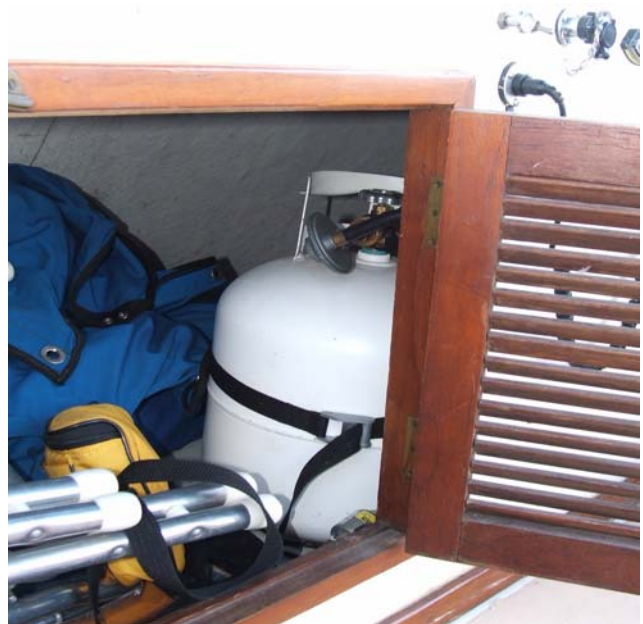
A galley stove is propane fueled and supplied from a 20lb. bottle inadequately secured by a nylon strap (see photo at right) under the flying bridge coaming.

The bottle is not stored in a "dedicated locker" and is exposed to the under dash DC electrical system. No dedicated or direct overboard drainage, remotely activated solenoid switch or pressure gauge is provided. See comment (10).

6. Transport Canada TP1332E requires and ABYC "Exhaust Systems" Standard P-1 recommends in part that all exhaust hose connections be double clamped.
10. NFPA-302 and ABYC " Marine Liquefied Petroleum Gas (LPG) Systems" Standard A-1 recommend that propane fuel bottles be stored securely in a dedicated, top loading locker with gasketed lid and direct overboard drainage from the bottom of that locker and that the system be fitted with a pressure gauge and a remotely controlled shut-off switch located at the appliance that may be reached without reaching over the appliance.

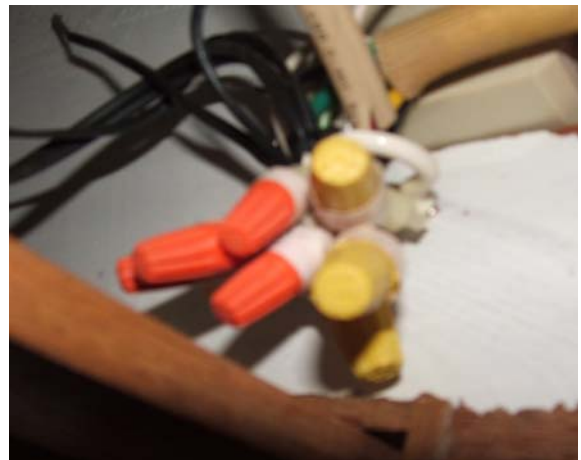
Conductors -- A mix of stranded and solid core copper conductors. The V-berth outlet (see photo at right) has seventeen conductors connected with seven wire twist connectors. See comment (13).

G.F.C.I. outlets -- One G.F.C.I. is fitted in the V-berth and the test button functions but there is no power from the outlet. See comment (14).

13. Transport Canada "Constructions Standards For Small Vessels", TP1332E requires conformance with ABYC "AC and DC Electrical Systems On Boats" Standard E-11 which in part requires that conductors be of stranded copper and be identified as having a minimum voltage rating of 600volts. That wire twist connectors are prohibited. *Seventeen conductors in seven wire twist connections is dangerous !*

14. This is the outlet mentioned in item13. and must be corrected immediately.
15. Transport Canada "Constructions Standards For Small Vessels", TP1332E requires conformance with ABYC "AC and DC Electrical Systems On Boats" Standard E-11 and NFPA 302 which in part require that the first outlet in each circuit and others where splash is likely. i.e. galley, shower, cockpit be protected with a G.F.C.I. and require that all AC outlets be contained in a box that meets UL514A or 514C.
