MARINE SURVEY REPORT

Report Number : 2006P/1004

Date of Inspection : August 18, 2006

Make of Vessel -- Marine Trader built by Chien Wha Yard, Taiwan.
Name of Vessel -- Christiana
Model year -- 1985
Date of mfg. -- February 1985
License Number -- 25E 11189
HIN/MIC -- ETY345858585

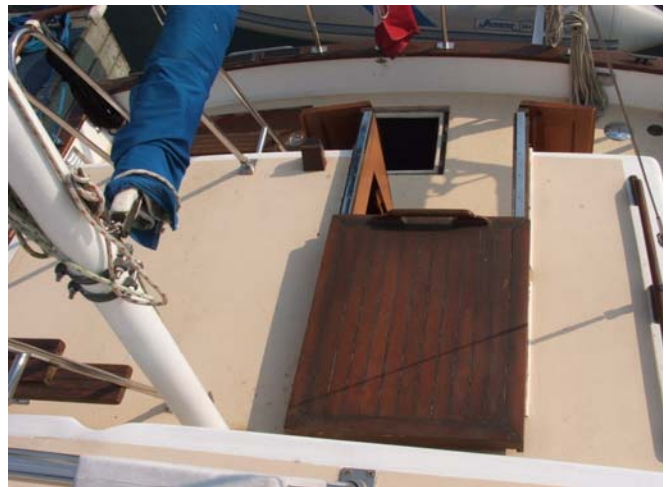
The aft deck is fitted with a plywood hatch cover which provides access to the steering gear and is warped but serviceably sound. A stainless steel ladder from the aft deck to the trunk top is secure. A sliding wooden companionway hatch and wooden doors to the aft cabin are secure and in good order.

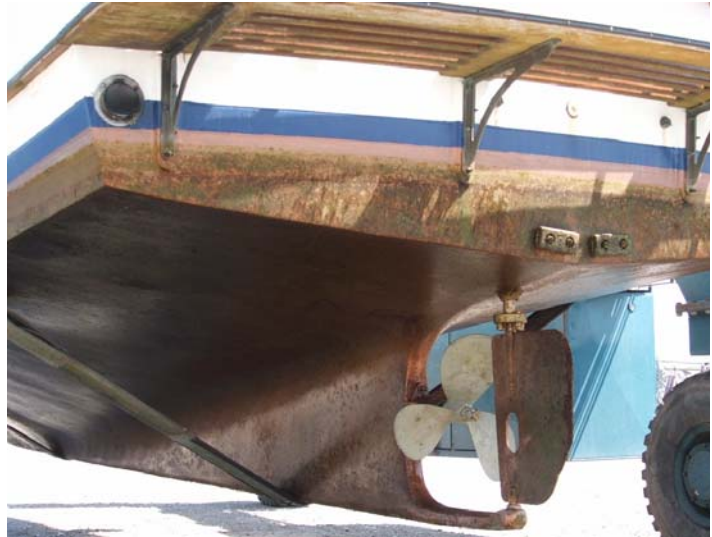
Propellers -- One 24LH16 three blade bronze unit in good order is secured on the shaft with a castellated nut, cotter pin and lock nut in good order.

Shaft system -- A stainless steel shaft is secured through a bronze log with cutless bearing to a compressible flange type stuffing box and polyurethane “drive saver” and conventional gear reduction flange in good condition.

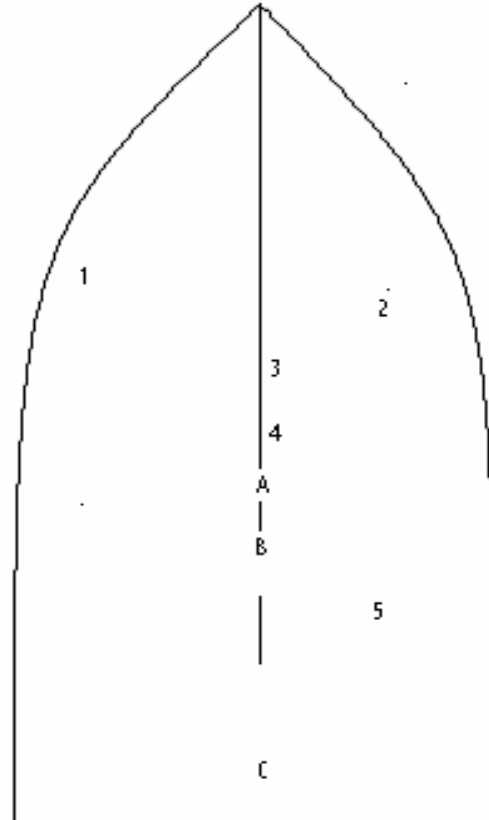
There are 3 electric bilge pumps

- A. Rule 12VDC unit.
- B. 12VDC submersible type of unidentified manufacture.
- C. Rule 12VDC unit.
